MANN+HUMMEL FM600 Oil Cleaning Centrifuge Maintenance Procedure

Applicable for the FM600-23 LF series Centrifuge Range

OIL CONDITIONING SYSTEMS SPARE PARTS LIST

FM600 - 23 LF SERIES

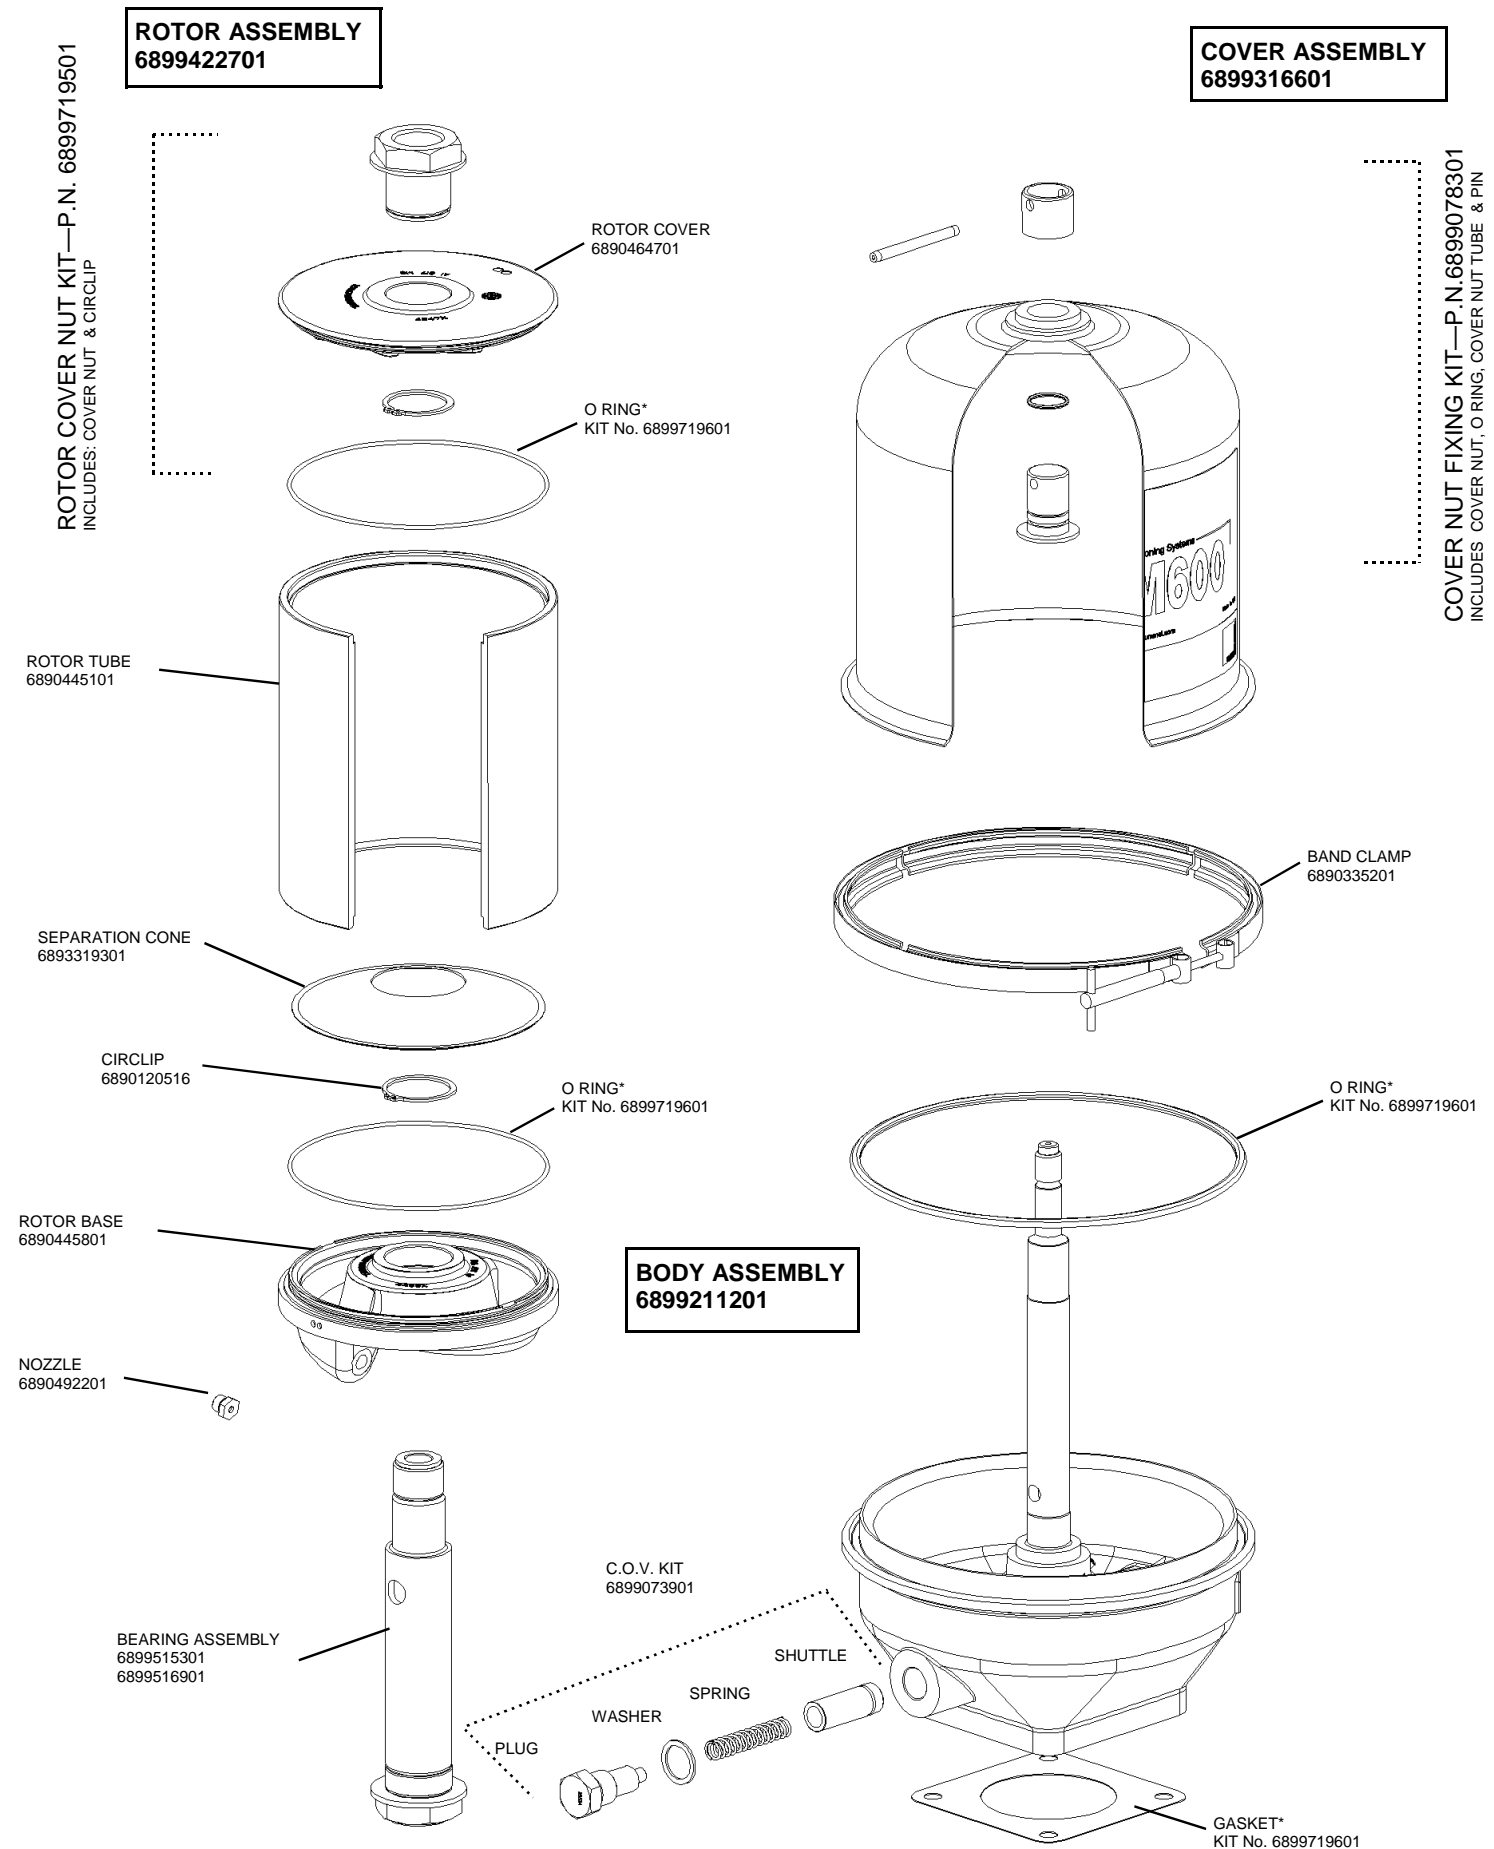
Spare Parts List

ROTOR ASSEMBLY	PART No.	QTY	
NOZZLE	6890492201	2	●
BEARING TUBE ASSEMBLY	6899517101	1	●
SEPARATION CONE	6893319301	1	●
CIRCLIP	6890120516	1	●
PAPER INSERT (NOT ILLUSTRATED)	6890302801	1	●
ROTOR TOP	6890464701	1	●
ROTOR BASE	6890445801		●
ROTOR TUBE	6890445101	1	●

COVER ASSEMBLY	PART No.	QTY	
COVER SUB-ASSEMBLY	6899069001	1	●

BAND CLAMP	PART No.	QTY	
	6890335201	1	●

FM600-LF KITS	PART No.	QTY	FM600-23 LF (6899146201)
CUT OFF VALVE (C.O.V) KIT	6899073901	1	
COVER NUT FIXING KIT	6899078301	1	●
ROTOR COVER NUT KIT	6899719501	1	●
SEALS KIT	6899719601	1	●

*SEALS KIT P.N. 6899719601 COMPRISES OF: C.O.V. WASHER, FILTER BODY O RING, CVR NUT O RING, 2 x RTR BODY O RINGS & BASE GASKET
